Smoke and Dye Testing Summary

High Level Sewershed

Test ID	Test Type	Date Inspected	Company / Super.	Blower MH	Ground Condition	Notification Made?	Total Length
S1028-019	Smoke	8/12/2008	ADS/TM	S09SS_004MH	Dry	Yes	2,478.19

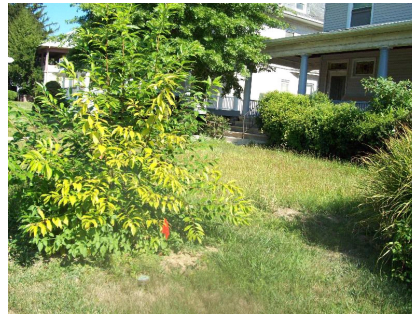
Picture \S1028-019-OB02-P01.jpg

Comments Smoke from cleanout in front yard. 3302 Powhatan Ave.

Comments Front of house, 3302 Powhatan Ave.

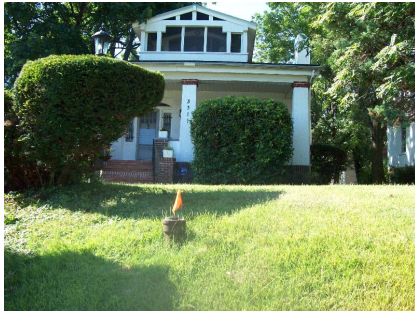
Picture \S1028-019-OB03-P01.jpg

Comments Smoke from cleanout in front yard. 3311 Powhatan Ave.

Comments Front of house, 3311 Powhatan Ave.

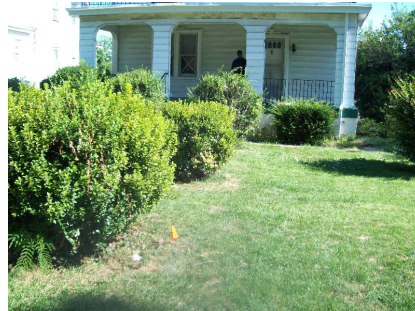
Picture \S1028-019-OB04-P01.jpg

Comments Smoke from cleanout in front yard. 3406 Powhatan Ave.

Comments Front of house, 3406 Powhatan Ave.

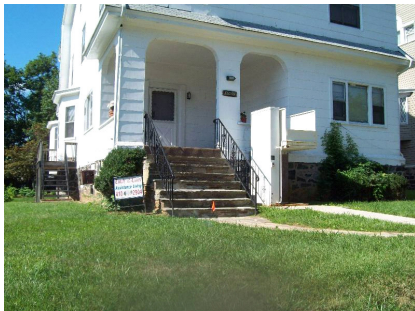
Picture \S1028-019-OB05-P01.jpg

Comments Smoke from cleanout in front yard. 3501 Powhatan Ave.

Comments Front of house, 3501 Powhatan Ave.
